BUILDING & TIMBER PEST **INSPECTION REPORT**

In accordance with AS 4349.1 & 4349.3

39517

1/18 Park Avenue, Auchenflower, QLD 4066

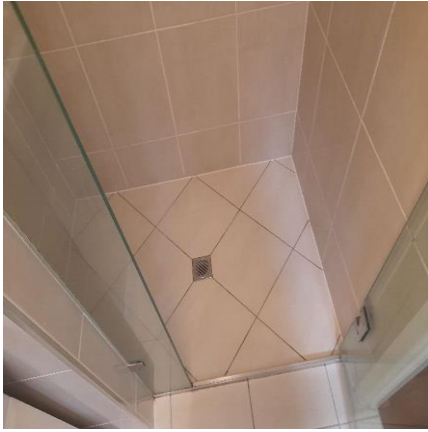
Check and maintain sealants to all wet areas.

Replace/install sealant to the internal corner and around the base of shower/s. Flexible sealant is required to these areas where differential movement takes place. Recommend seeking further advice from a licenced and practicing wall and floor tiler.

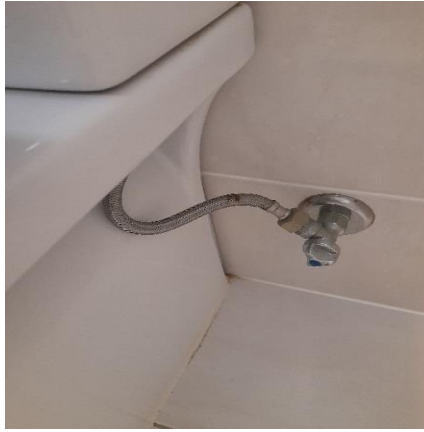
Bathroom toilet: Braided flexible hose has signs of rust to WC tap connections. Hoses require replacement. Recommend contacting a licenced and practicing plumbing contractor for clarification and/ or rectification.

The above recommendation(s) should be implemented as a matter of importance

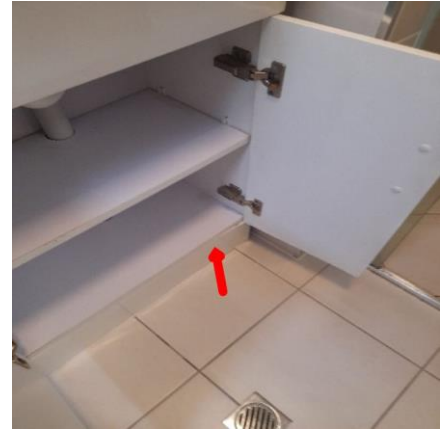
Excessive wear/moisture damage to internal of bathroom cabinets (e.g. below sink/tub/kick board area).

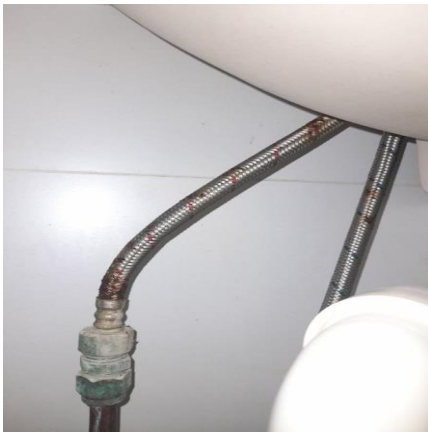
Ensuite: Braided flexible hose has signs of rust to Sink/Basin/ WC tap connections. Hoses require replacement. Recommend contacting a licenced and practicing plumbing contractor for clarification and/ or rectification.

The above recommendation(s) should be implemented as a matter of importance

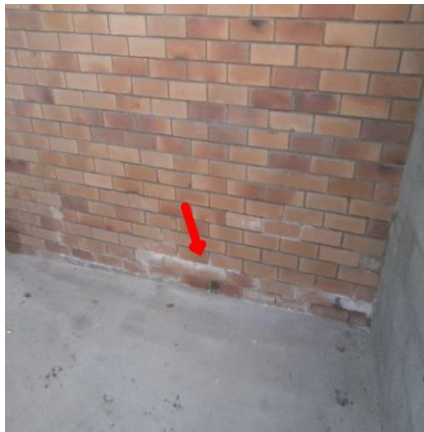
There is efflorescence/salt attack to garage brickwork, this is a normal process of wetting and drying to brickwork, however long term efflorescence may deteriorate brickwork and should be monitored, if concern arises a specialist in water proofing should be consulted.

Refer to the Body Corporate for further information/clarification of this issue.

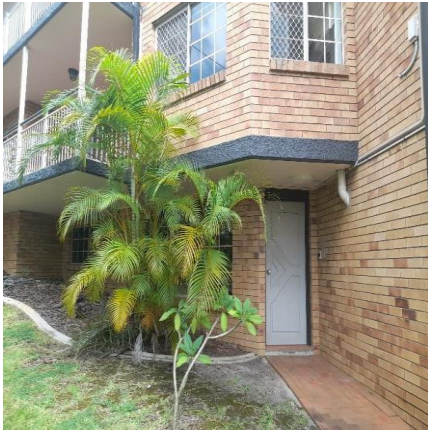
Note: Mature trees and large shrubs located in close proximity to the building (within 3m). Having trees and shrubs close to the building can lead to problems such as leaves blocking gutters and downpipes, trees falling onto the house and root systems damaging paths/paving, undermining the building footings and damage to underground plumbing services. Recommend engaging a suitably qualified and experienced arborist (tree specialist) to give further advise as to the risk of damage, the most appropriate method of rectification and associated costs of rectification where required. Botanical gardens and local authorities can also be a source of such information. AS 2870-2011 "Residential Slabs and Footings" advises that trees growing in extremely reactive soils (Class E sites), should be planted a distance equivalent to 1½ x mature height from the house. For highly reactive soils (Class H), 1 x mature height and moderately reactive soils, (Class M sites), ¾ x mature height. In all cases, for the best property

Strongly recommend the removal of trees/Palms against/striking the dwelling.

The above recommendation(s) should be implemented as a matter of importance

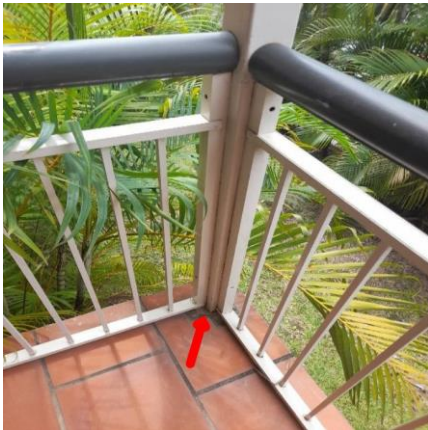
Rust scale detected to the bottom of steel handrail posts at tile level. Rust treatment is required to prevent further corrosion affecting the structural integrity of the post.

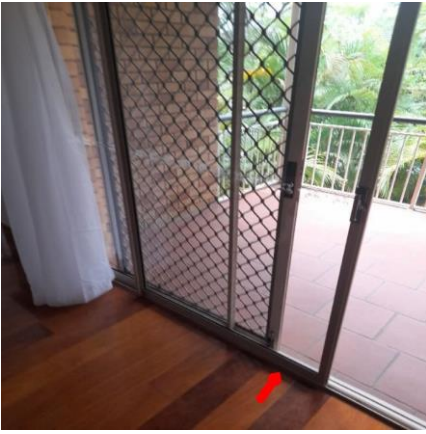
Aluminium sliding window/door rollers require maintenance, heavy to slide. Refer to general maintenance tip sheet.

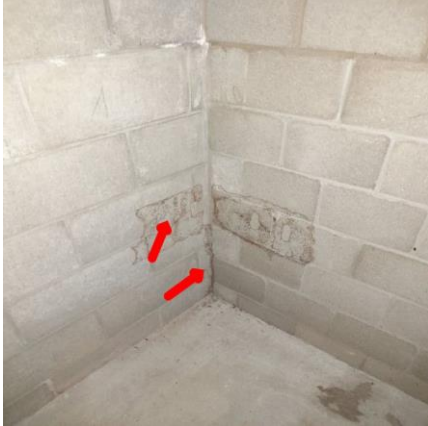
Old termite sign to garage area requires ongoing monitoring.

Termite damage or workings were located in the following: **Evidence of old termite activity/ workings/ damage was located but not restricted to the following areas garage wall. Where termite workings/damage is located, regular monitoring of these areas should be implemented as termites can temporarily retreat due to the disturbance of the inspection and/or other termites can inhabit the workings. Therefore, what may appear to be inactive may only be dormant especially if there is no evidence of a past treatment.**

Refer to the Body Corporate for further information/clarification of this issue.

RECOMMENDATION; Where evidence of damage to building timbers exists or is undetermined, competent advice (e.g. from a licensed and practicing building contractor) should be obtained to determine the extent of any structural damage and as to the need or otherwise for rectification or repair work. See also Item 3.5 'Frequency of Future Inspections' recommendation

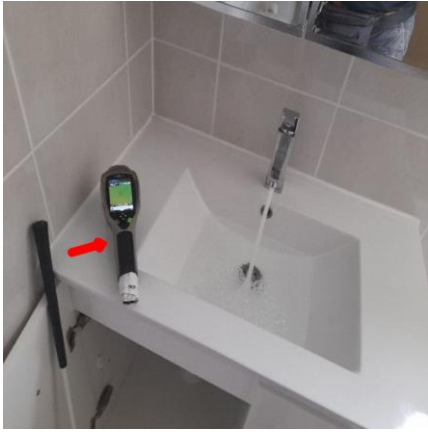
This inspection was carried out with the aid of a thermal imaging camera. On the day of this Inspection the camera did not register any abnormal temperature variances within the dwelling that may indicate the presence of a large active termite infestation.
